**Flood Control Project Maintenance  
Levee Inspections****LMA District Cover Sheet****Spring 2016 Levee Inspection Results****Reclamation District No. 0349 Sutter Island**

**Levee Inspection Report By Mile - Spring 2016**

**Reclamation District No. 0349 Sutter Island**

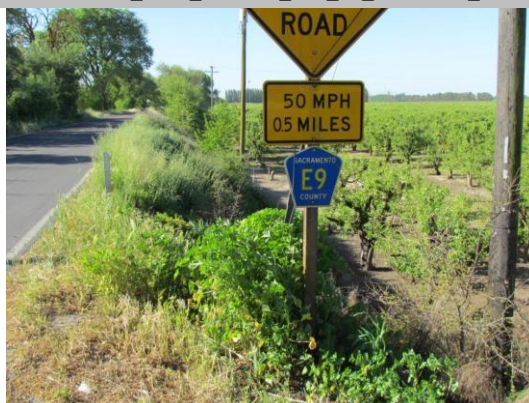
Photo 1 of 1 : SP\_2016\_RD0349\_204\_19\_20160405\_00026.jpg

LM Start	0.01	Rating **	U	Issue No.	19
LM End	1.28	Issue Type +	Ma	Location *	LS
Category	Earthen Levee			GPS Latitude/Longitude	
				Start	End
Item	Vegetation			38.327073 °	38.309137 °
				-121.576945 °	-121.576982 °
DWR ID	DWR_RD0349_01_s_2016_19				
Comment Code					
V1 : Control annual grass and weeds on the levee slopes and easements.					
Inspector Comment					
Remove the unwanted tall weeds from the landside levee slope. Weeds growing out of control in the landscape areas need to be maintained as a condition of the permit. Those that has a CVFPB Permit.

Looking down from levee mile 0.01 landside levee slope unit 1 RD 349.

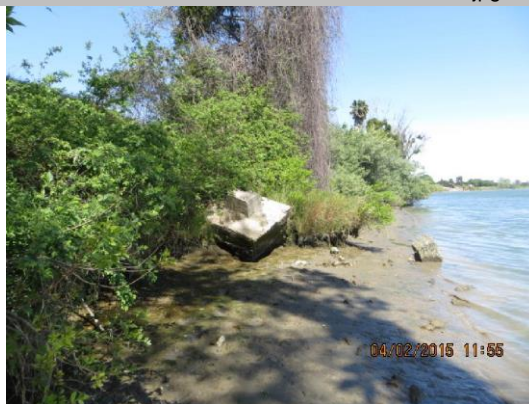
Photo 2 of 2 : UCIP\_SP\_2016\_44303\_73621.jpg

Concrete debris on WS toe is a good indicator of pump location.

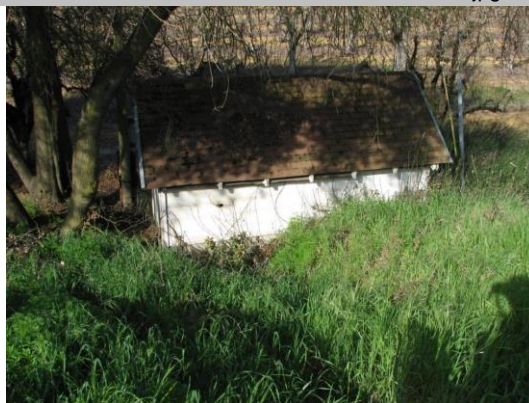
Photo 2 of 2 : UCIP\_SP\_2016\_21572\_36573.jpg

FS\_ID:21572  
DS\_ID:24521  
EP\_NO: N/A  
Repair Type: Non-Urgent  
Crossing Status: Found  
UCIP Comments: No records were found during initial desk study--need to contact owner to obtain permit number authorizing work. If crossing is no longer used by owner, the owner will need to coordinate with DWR Inspector and CVFPB to remove crossing according to Title 23 requirements. Dense vegetation limits the inspector's visibility to identify signs of pipe failure (leaks) along the slope. Recommend removing vegetation along pipe alignment to conduct proper inspection of structure and appurtenances. Note date on photos should be 3/18/09 not 7/26/08 camera metadata is incorrect.  
FIELD\_STRUCT\_DESC: Abandoned 8-inch pipe through the levee, 13.9 feet below the crown. Pump on platform at landward toe. Service pole on landward slope.  
FS Date: 3/18/2009

Pump house located on landward side at toe.

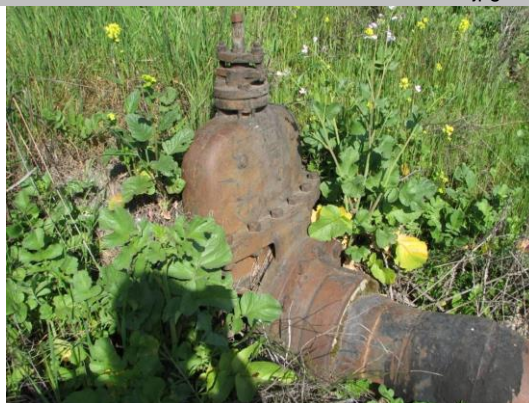
Photo 2 of 2 : UCIP\_SP\_2016\_39872\_36562.jpg

FS\_ID:39872  
DS\_ID:24140  
EP\_NO: N/A  
Repair Type: Urgent  
Crossing Status: Found  
UCIP Comments: Exposed section of levee slope on landward side-- need to contact owner and DWR inspector. Dense vegetation limits the inspector's visibility to identify signs of pipe failure (leaks) along the slope. Recommend removing vegetation along pipe alignment to conduct proper inspection of structure and appurtenances. Note date on photos should be 3/18/09 not 7/26/08 camera metadata is incorrect.  
FIELD\_STRUCT\_DESC: 14-inch pipe (waterward shoulder) and 12-inch pipe (landward shoulder) through the levee, 4.7 feet below the crown. Gate valve on the waterward slope. Pump in pumphouse on landward slope. Pressure breaker behind pumphouse. Pipe exposed on waterward slope. (USACE-1959). This entry matches the Drainage or Irrigation Structure referenced in O&M manual (HLM 1.1).  
FS Date: 3/18/2009

View of gate with missing handle located on waterward slope.

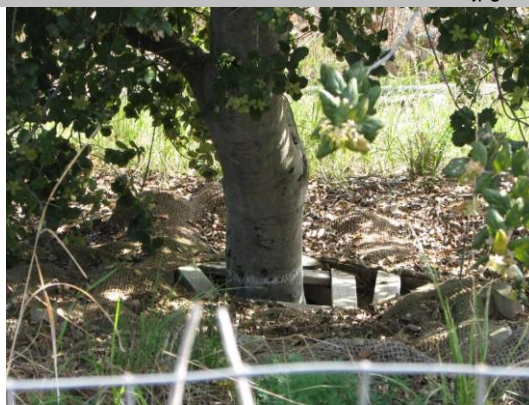
Photo 1 of 2 : UCIP\_SP\_2016\_44304\_36580.jpg

Comment Code					
Inspector Comment					
FS_ID:44304 DS_ID:24141 EP_NO: N/A Repair Type: Non-Urgent Crossing Status: Found UCIP Comments: 2007 DWR erosion repair site location?--need to find out fate of crossing. Dense vegetation limits the inspector's visibility to identify signs of pipe failure (leaks) along the slope. Recommend removing vegetation along pipe alignment to conduct proper inspection of structure and appurtenances. Note date on photos should be 3/18/09 not 7/26/08 camera metadata is incorrect. FIELD_STRUCT_DESC: Pumphouse at landward toe. Pressure breaker on landward side. Electromagnetic Survey indicated a crossing at this location as well. FS Date: 4/2/2015

Geotech fabric and protective frame at tree--design features of erosion repair site 2007-2009.

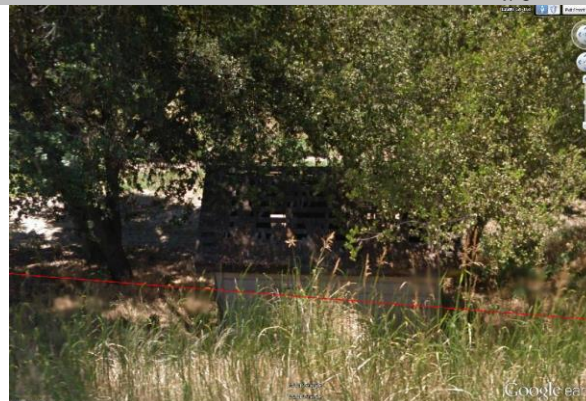
Photo 2 of 2 : UCIP\_SP\_2016\_44304\_73625.jpg

Comment Code						
Inspector Comment						
FS_ID:44304						
DS_ID:24141						
EP_NO: N/A						
Repair Type: Non-Urgent						
Crossing Status: Found						
UCIP Comments: 2007 DWR erosion repair site location?--need to find out fate of crossing. Dense vegetation limits the inspector's visibility to identify signs of pipe failure (leaks) along the slope. Recommend removing vegetation along pipe alignment to conduct proper inspection of structure and appurtenances. Note date on photos should be 3/18/09 not 7/26/08 camera metadata is incorrect.						
FIELD_STRUCT_DESC: Pumphouse at landward toe. Pressure breaker on landward side. Electromagnetic Survey indicated a crossing at this location as well.						
FS Date: 4/2/2015

Pumphouse on LS toe (From google view)

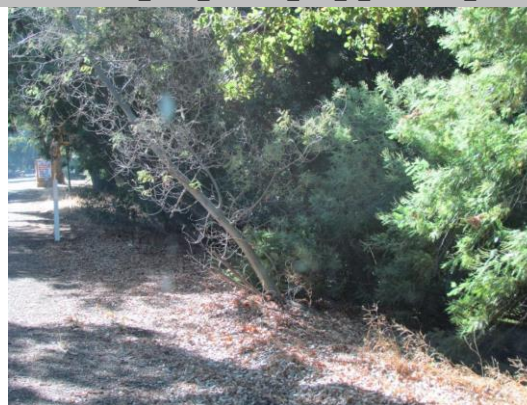
Photo 1 of 1 : SP\_2016\_RD0349\_204\_6\_20160223\_00004.jpg

LM Start	1.38	Rating **	U	Issue No.	6
LM End	1.41	Issue Type +	Ma	Location *	LS
Category	Earthen Levee			GPS Latitude/Longitude	
				Start	End
Item	Vegetation			38.307880 °	38.307453 °
				-121.576068 °	-121.575735 °
DWR ID	DWR_RD0349_01_f_2015_6				
Comment Code					
V2 : Remove the wild growth other than native grasses from the levee slopes.					
Inspector Comment					
Remove the woody tree growth from the landside levee slope and toe.

Unsatisfactory woody tree growth on the landside levee slope.

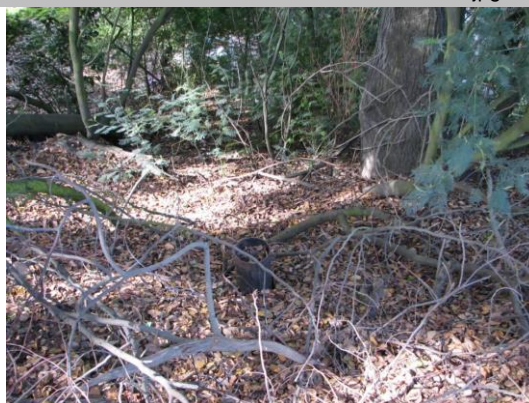
Photo 2 of 2 : UCIP\_SP\_2016\_44214\_36571.jpg

FS\_ID:44214  
DS\_ID:24143  
EP\_NO: 12005  
Repair Type: Non-Urgent  
Crossing Status: Found  
UCIP Comments: Pipe open on WS slope. 2007 Erosion Repair Site location?--Need to contact owner to determine if crossing is still in use. Dense vegetation limits the inspector's visibility to identify signs of pipe failure (leaks) along the slope. Recommend removing vegetation along pipe alignment to conduct proper inspection of structure and appurtenances. Note date on photos should be 3/18/09 not 7/26/08 camera metadata is incorrect.  
FIELD\_STRUCT\_DESC: 6-inch steel irrigation pipe, 4.0 feet below the crown. Siphon breaker and protective housing at levee shoulder. Pump on waterward side. Pipe exposed on waterward slope, extending to pump. Discharge structure at landward toe. (Permit No. 12005-1977)  
FS Date: 4/2/2015

Pipe located on landward side--unable to determine whether it belongs to crossing.

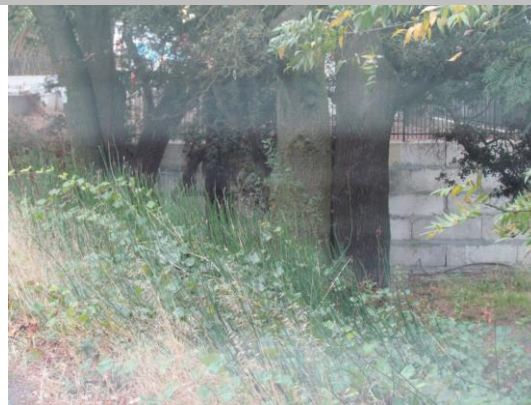
Photo 1 of 1 : SP\_2016\_RD0349\_204\_12\_20160223\_00005.jpg

Looking downstream at levee mile 1.55 unauthorized block wall placed on landward levee section, no CVFPB Permit.

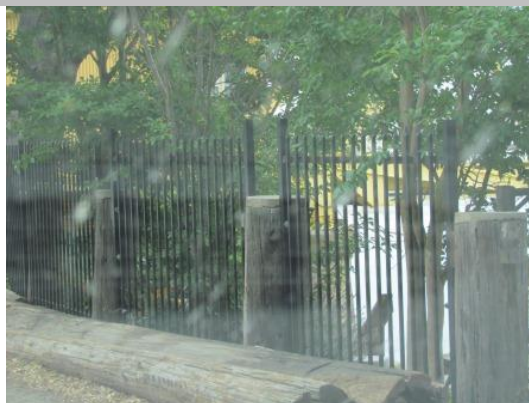
Photo 2 of 2 : SP\_2016\_RD0349\_205\_4\_20160223\_00006.jpg

Unauthorized fence adjacent to building waterside Sutter Slough.

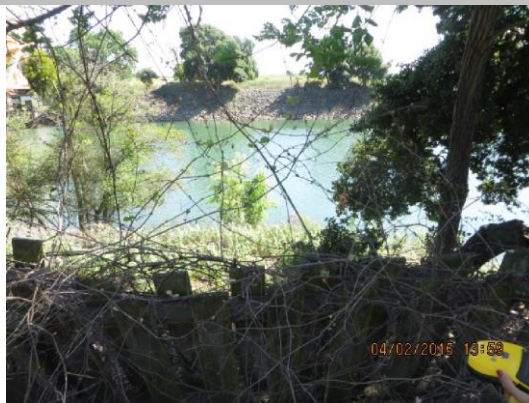
Photo 2 of 2 : UCIP\_SP\_2016\_46169\_74546.jpg

FS\_ID:46169  
DS\_ID:25098  
EP\_NO: N/A  
Repair Type: Non-Urgent  
Crossing Status: Found  
UCIP Comments: Appears abandoned and if so should be done so properly. Need to identify permit.  
FIELD\_STRUCT\_DESC: 1-inch waterline through the levee 1.5-feet below the crown. Pipe visible at fence on WS slope.  
FS Date: 4/9/2015

Fence on WS shoulder.

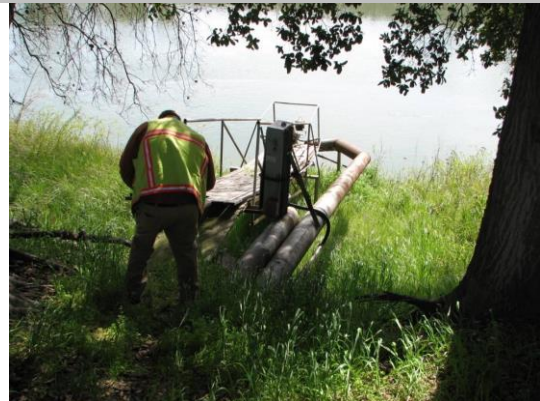
Photo 1 of 2 : UCIP\_SP\_2016\_21576\_36593.jpg

Comment Code					
Inspector Comment					
FS_ID:21576 DS_ID:24145 EP_NO: N/A Repair Type: Non-Urgent Crossing Status: Found UCIP Comments: No connection present--need to contact owner to determine if owner plans to use. If crossing is no longer in use owner will need to coordinate with DWR inspector and CVFPB to remove according to Title 23 requirements. Dense vegetation limits the inspector's visibility to identify signs of pipe failure (leaks) along the slope. Recommend removing vegetation along pipe alignment to conduct proper inspection of structure and appurtenances. Unable to determine if crossing is in use. Note date on photos should be 3/18/09 not 7/26/08 camera metadata is incorrect. FIELD_STRUCT_DESC: Abandoned 10-inch pipe through the levee, 6.0 feet below the crown. Pump and slide gate on the waterward slope. Concrete pipe riser and distribution box at the landward toe. Service pole and anchor on the landward slope. FS Date: 3/18/2009

Dense vegetation on waterward slope--2 pipes and 1 conduit.

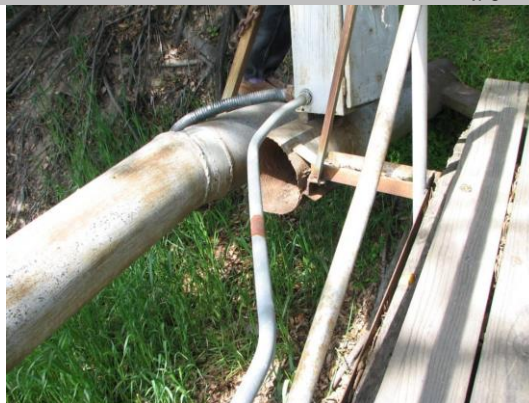
Photo 2 of 2 : UCIP\_SP\_2016\_21576\_36592.jpg

Comment Code						
Inspector Comment						
FS_ID:21576 DS_ID:24145 EP_NO: N/A Repair Type: Non-Urgent Crossing Status: Found UCIP Comments: No connection present--need to contact owner to determine if owner plans to use. If crossing is no longer in use owner will need to coordinate with DWR inspector and CVFPB to remove according to Title 23 requirements. Dense vegetation limits the inspector's visibility to identify signs of pipe failure (leaks) along the slope. Recommend removing vegetation along pipe alignment to conduct proper inspection of structure and appurtenances. Unable to determine if crossing is in use. Note date on photos should be 3/18/09 not 7/26/08 camera metadata is incorrect. FIELD_STRUCT_DESC: Abandoned 10-inch pipe through the levee, 6.0 feet below the crown. Pump and slide gate on the waterward slope. Concrete pipe riser and distribution box at the landward toe. Service pole and anchor on the landward slope. FS Date: 3/18/2009

Pipes through levee at waterward slope.

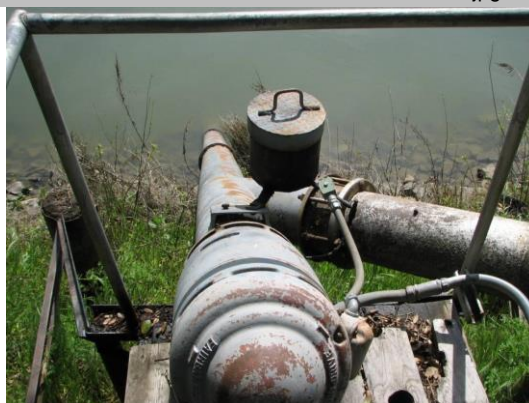
Photo 2 of 2 : UCIP\_SP\_2016\_21577\_36596.jpg

Comment Code						
Inspector Comment						
FS_ID:21577						
DS_ID:24146						
EP_NO: 2480						
Repair Type: Non-Urgent						
Crossing Status: Found						
UCIP Comments: Dense vegetation limits the inspector's visibility to identify signs of pipe failure (leaks) along the landward slope.						
Recommend removing vegetation along pipe alignment to conduct proper inspection of structure and appurtenances. Unable to determine if crossing is in use. Note date on photos should be 3/18/09 not 7/26/08 camera metadata is incorrect.						
FIELD_STRUCT_DESC: 10-inch steel pipe through the levee, 6.0 feet below the crown. Pump and slide gate on the waterward slope.						
Concrete pipe riser and distribution box with gate valve at the landward toe. Service pole and anchor on the landward slope. (Permit No. 2480-1959)						
FS Date: 3/18/2009

View of waterward side--pump and raised platform.

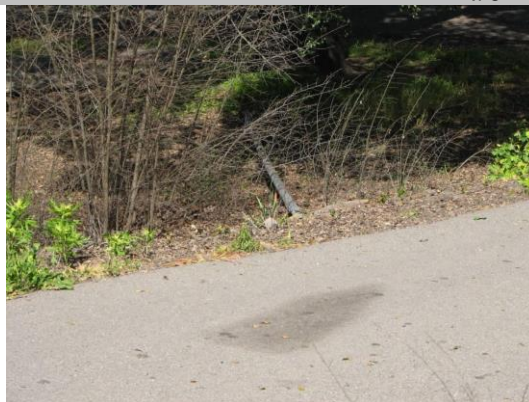
Photo 2 of 2 : UCIP\_SP\_2016\_21613\_36687.jpg

FS\_ID:21613  
DS\_ID:24147  
EP\_NO: N/A  
Repair Type: Non-Urgent  
Crossing Status: Found  
UCIP Comments: Dense vegetation limits the inspector's visibility to identify signs of pipe failure (leaks) along the slope. Recommend removing vegetation along pipe alignment to conduct proper inspection of structure and appurtenances. Note date on photos should be 3/18/09 not 7/26/08 camera metadata is incorrect.  
FIELD\_STRUCT\_DESC: 3-inch pipe through the levee, 3.3 feet below the crown. Gate valve on landward side. (USACE-1959). This entry matches the Drainage or Irrigation Structure referenced in O&M manual (HLM 0.1).  
FS Date: 3/18/2009

View of crossing on landward side.

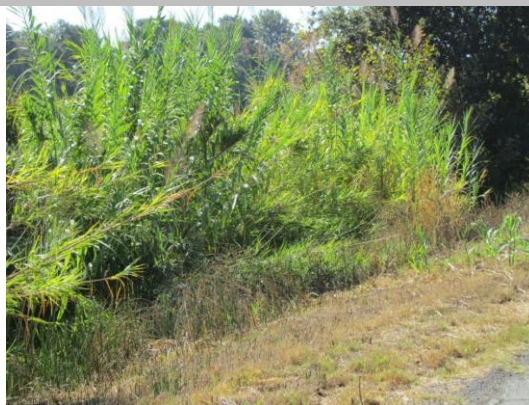
Photo 1 of 1 : SP\_2016\_RD0349\_205\_68\_20160223\_00018.jpg

Landside levee slope and toe covered with arundo from levee mile 0.27-0.28.

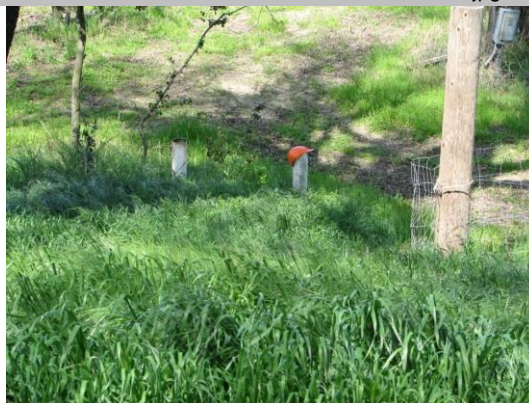
Photo 1 of 2 : UCIP\_SP\_2016\_21614\_36691.jpg

Comment Code					
Inspector Comment					
FS_ID:21614 DS_ID:24148 EP_NO: 12006 Repair Type: Non-Urgent Crossing Status: Found UCIP Comments: Altered crossing--contact owner to obtain new permit authoring work. Debris remains on site. Dense vegetation limits the inspector's visibility to identify signs of pipe failure (leaks) along the slope. Recommend removing vegetation along pipe alignment to conduct proper inspection of structure and appurtenances. Note date on photos should be 3/18/09 not 7/26/08 camera metadata is incorrect. FIELD_STRUCT_DESC: 6-inch steel irrigation pipe through the levee, 4.0 feet below the crown. 3-inch conduit through levee to service pump. Steel cutoff wall around pipe at center of levee. Siphon breaker in concrete riser at landward shoulder. Gate valve on landward side. Pump on concrete pad on waterward slope. Discharge structure at landward toe. (Permit No. 12006-1977) FS Date: 3/18/2009

View of landward side--unable to inspect.

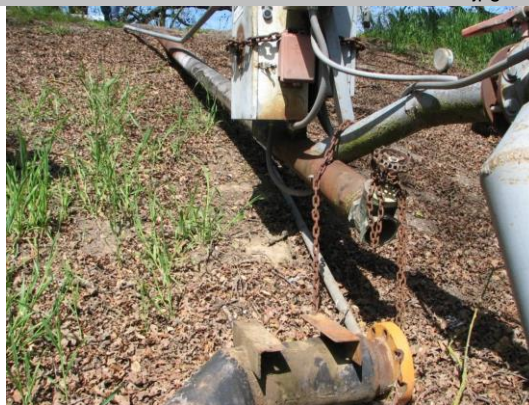
Photo 2 of 2 : UCIP\_SP\_2016\_21614\_36690.jpg

Crossing has been altered--abandoned pipe through levee slope remains.

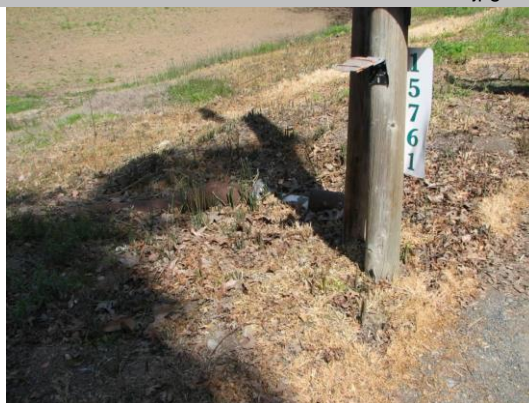
Photo 2 of 2 : UCIP\_SP\_2016\_21615\_36695.jpg

View of landard shoulder--service pole and pipe section through slope.

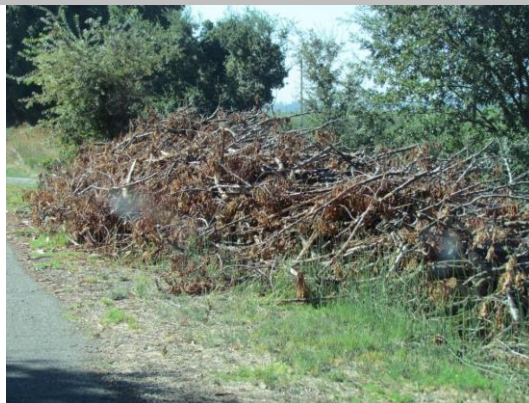
Photo 1 of 1 : SP\_2016\_RD0349\_205\_79\_20160223\_00021.jpg

Under the brush pile is some erosion along the landside slope.

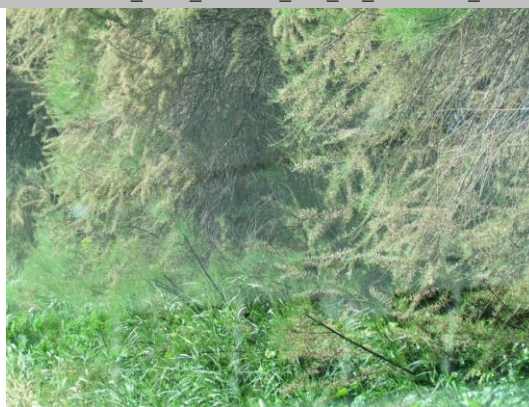
Photo 1 of 1 : SP\_2016\_RD0349\_205\_56\_20160411\_00080.jpg

Looking downstream from levee mile 1.33 woody tree growth on the slope.

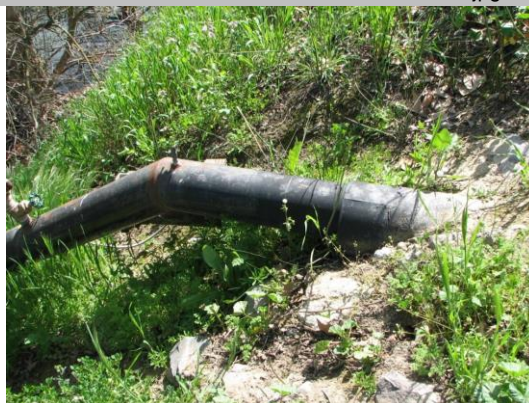
Photo 2 of 2 : UCIP\_SP\_2016\_21606\_36654.jpg

Smaller pipe sleeved through larger pipe that goes through levee.

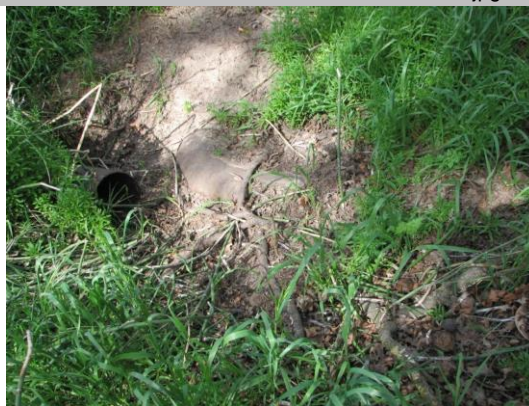
Photo 2 of 2 : UCIP\_SP\_2016\_21609\_36667.jpg

Debris along pipe alignment.

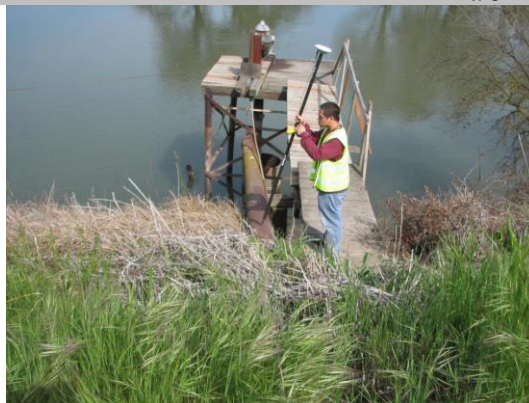
Photo 2 of 2 : UCIP\_SP\_2016\_39873\_36676.jpg

Overview of waterward side--dense vegetation limits slope inspection.

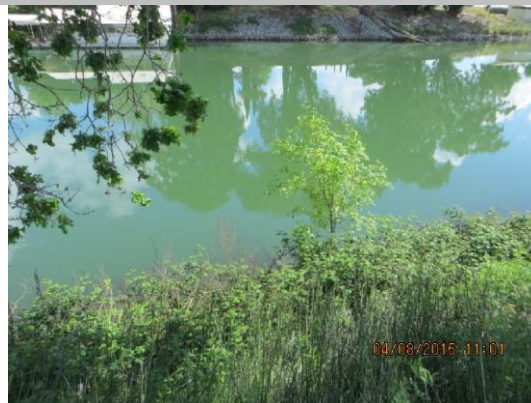
Photo 1 of 2 : UCIP\_SP\_2016\_44328\_73707.jpg

Pipe visible in water at WS toe.

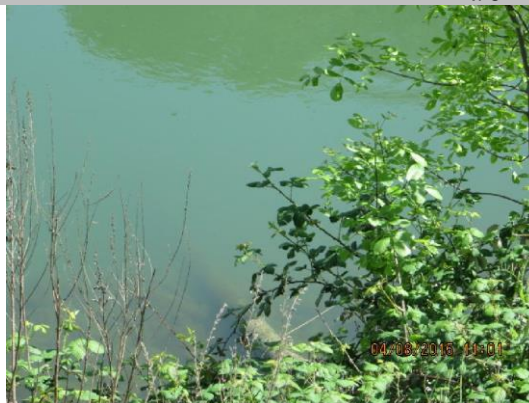
Photo 2 of 2 : UCIP\_SP\_2016\_44328\_73706.jpg

Pipe visible in water at WS toe.

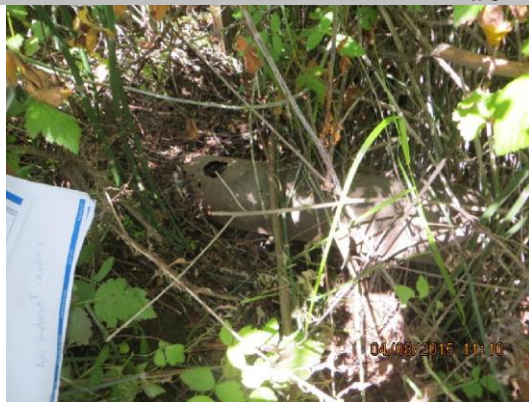
Photo 2 of 2 : UCIP\_SP\_2016\_44331\_73708.jpg

Abandoned pipe visible on slope in vegetation behind new pipe on WS slope.

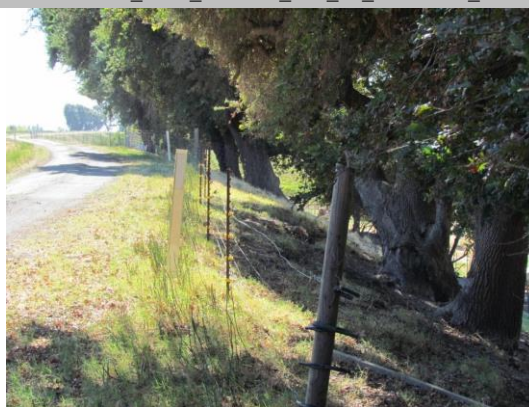
Photo 1 of 4 : SP\_2016\_RD0349\_205\_59\_20160223\_00015.jpg

Unauthorized electric wire fence installed along the shoulder and levee slope.

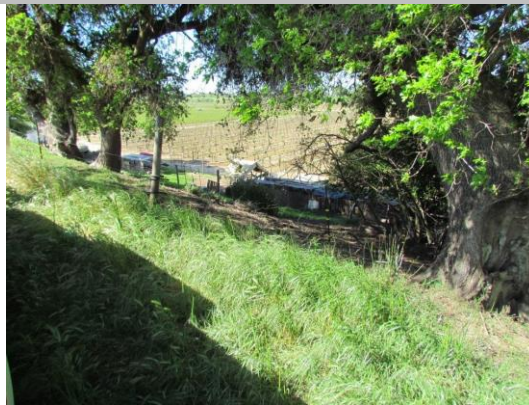
Photo 4 of 4 : SP\_2016\_RD0349\_205\_59\_20160422\_00085.jpg

Unauthorized electric fence installed along the landside shoulder and slope.

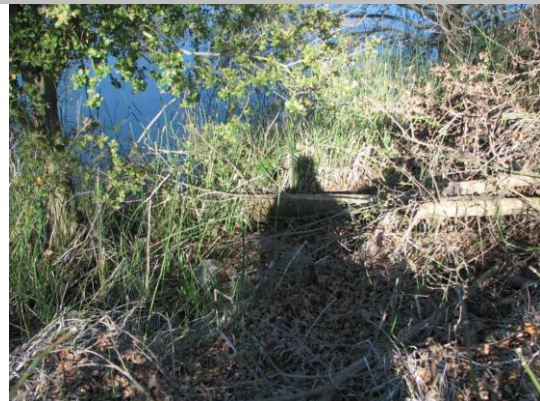
Photo 1 of 2 : UCIP\_SP\_2016\_43442\_36707.jpg

View of waterward side--portion of pipe exposed on slope.

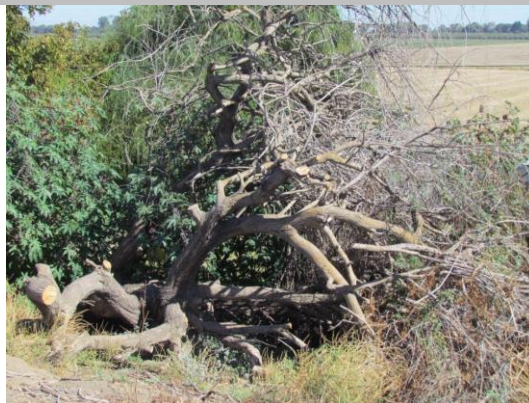
Photo 1 of 1 : SP\_2016\_RD0349\_206\_971\_20160223\_00013.jpg

The dead tree listed in last inspection has not been completely removed, nor has the woody tree growth been thinned out.

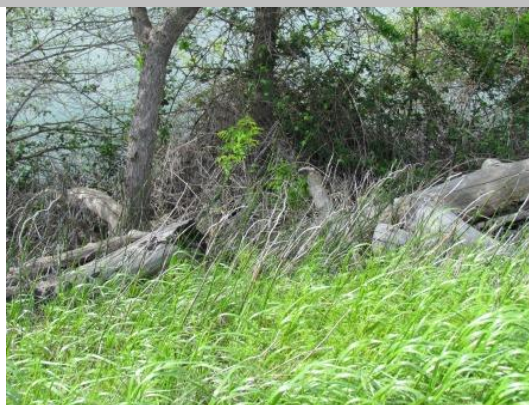
Photo 1 of 1 : SP\_2016\_RD0349\_206\_64\_20160223\_00006.jpg

Cut up fallen tree on waterside slope.

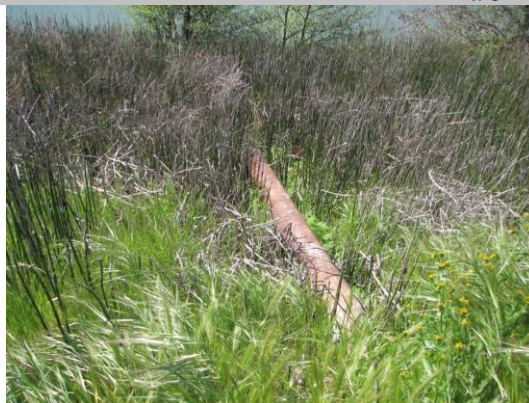
Photo 2 of 2 : UCIP\_SP\_2016\_21634\_36738.jpg

View of waterward side--dense vegetation limits inspection.

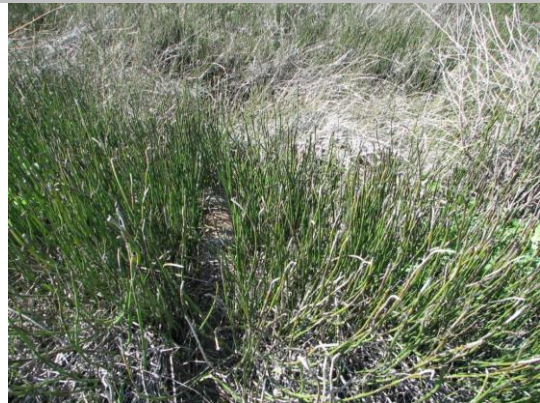
Photo 1 of 2 : UCIP\_SP\_2016\_43423\_36866.jpg

View of waterward side--dense vegetation covers slope.

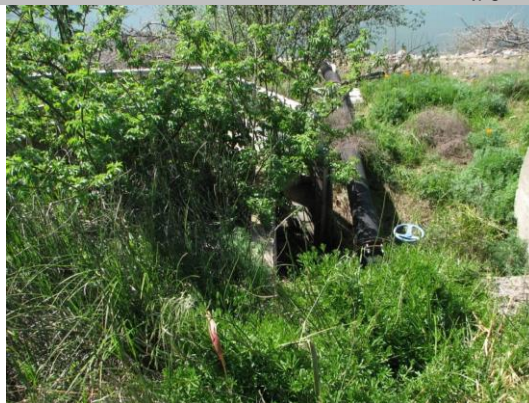
Photo 1 of 2 : UCIP\_SP\_2016\_43424\_36869.jpg

Waterward side--appears to be an erosion repair site. New pipe on waterward side and damaged pipe on landward side.

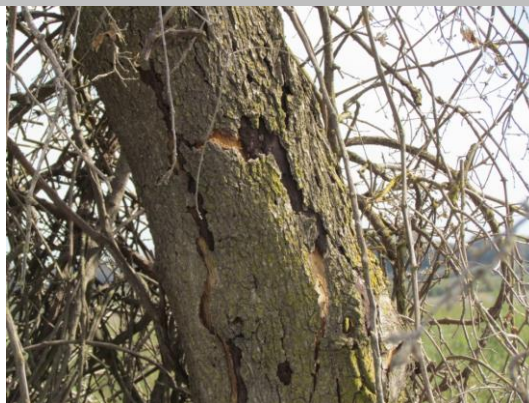
Photo 2 of 2 : SP\_2016\_RD0349\_206\_73\_20160223\_00010.jpg

Close up view of dead tree standing above crown roadway.

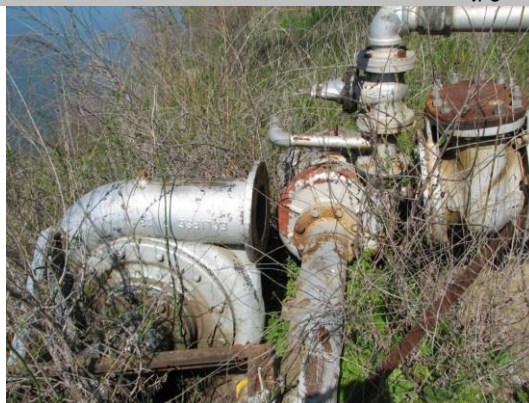
Photo 2 of 2 : UCIP\_SP\_2016\_43459\_36795.jpg

Pump located on waterward side is not connected.

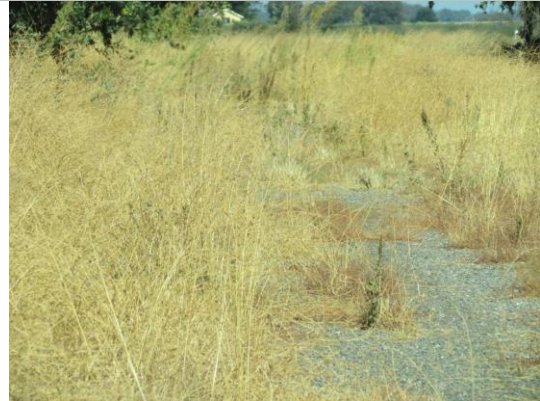
Photo 1 of 1 : SP\_2016\_RD0349\_206\_80\_20160223\_00012.jpg

RD 349 Levee mile 4.74 looking at overgrown crown roadway. Weeds are taller than four feet. Extreme fire hazard.
